# **Final Report**

**from the examination of the aviation accident no  
192/2010/11**

**involving the Tu-154M airplane, tail number 101,  
which occurred on April 10<sup>th</sup>, 2010**

**in the area of the SMOLENSK NORTH airfield**

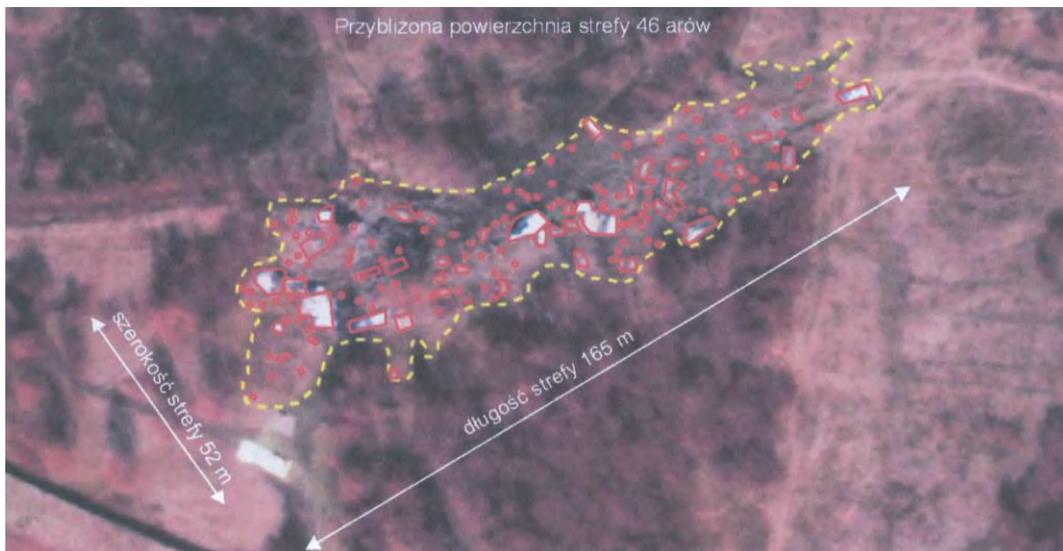
- broken power line,
- many broken trees and shrubs along the final phase of the flight,
- woodland devastation, about 52 m wide and 165 m long on the site of aircraft's fall.

Fig.1. A sketch of damage caused by the aircraft<sup>6</sup> striking the ground. (dotted area)

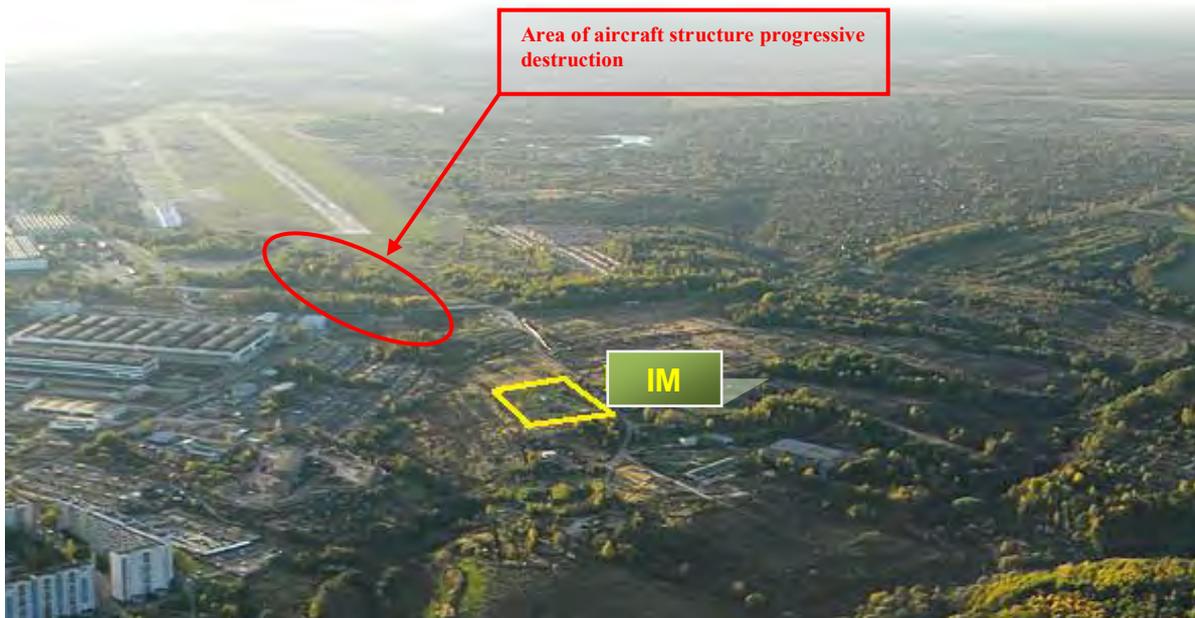
Fig. 8. Place where aircraft struck obstacles and the ground

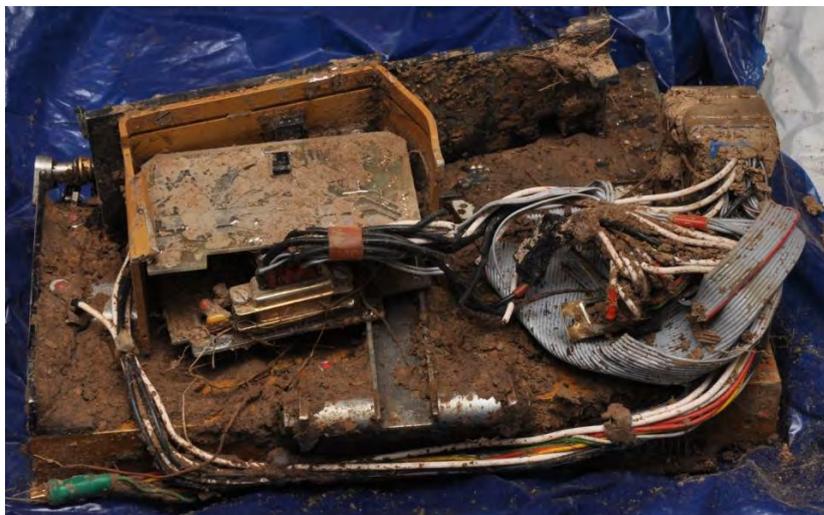
Photo 10.Quick Access Recorder ATM-QAR on the site of crash

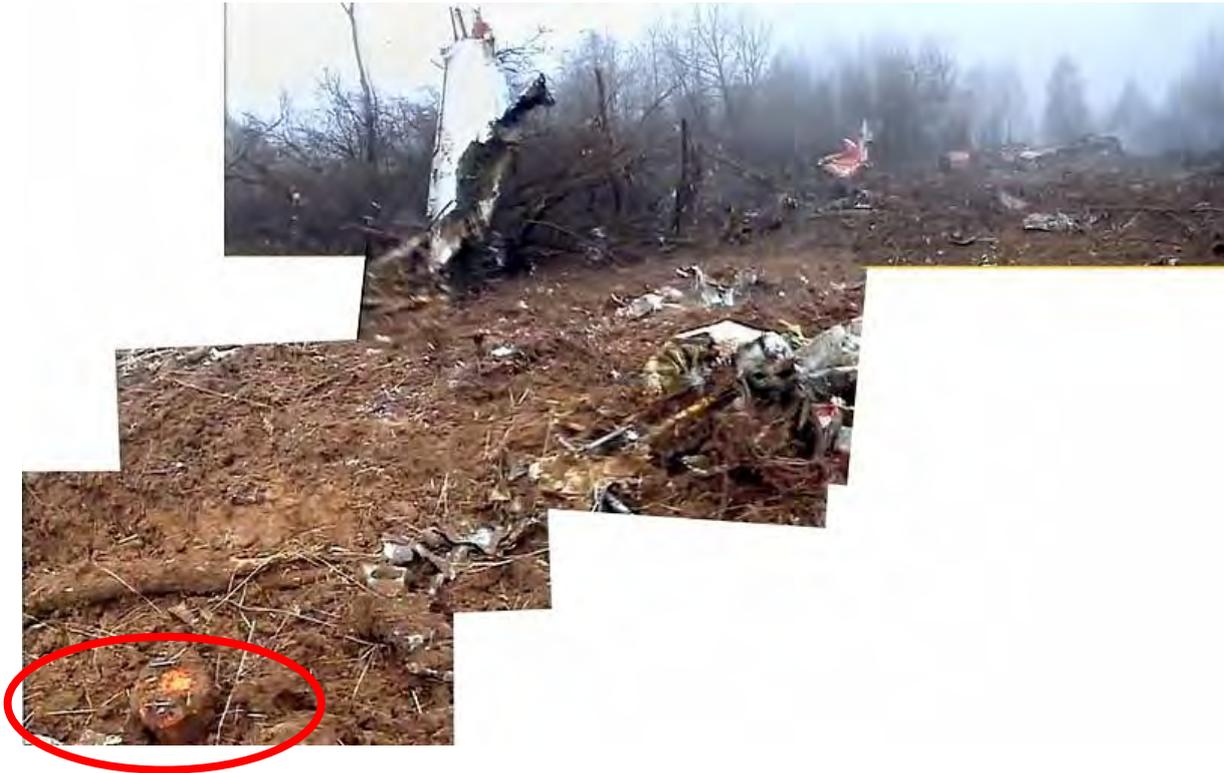
Photo 13. Unit 70A-10M of MARS-BM voice recorder on the site of crash

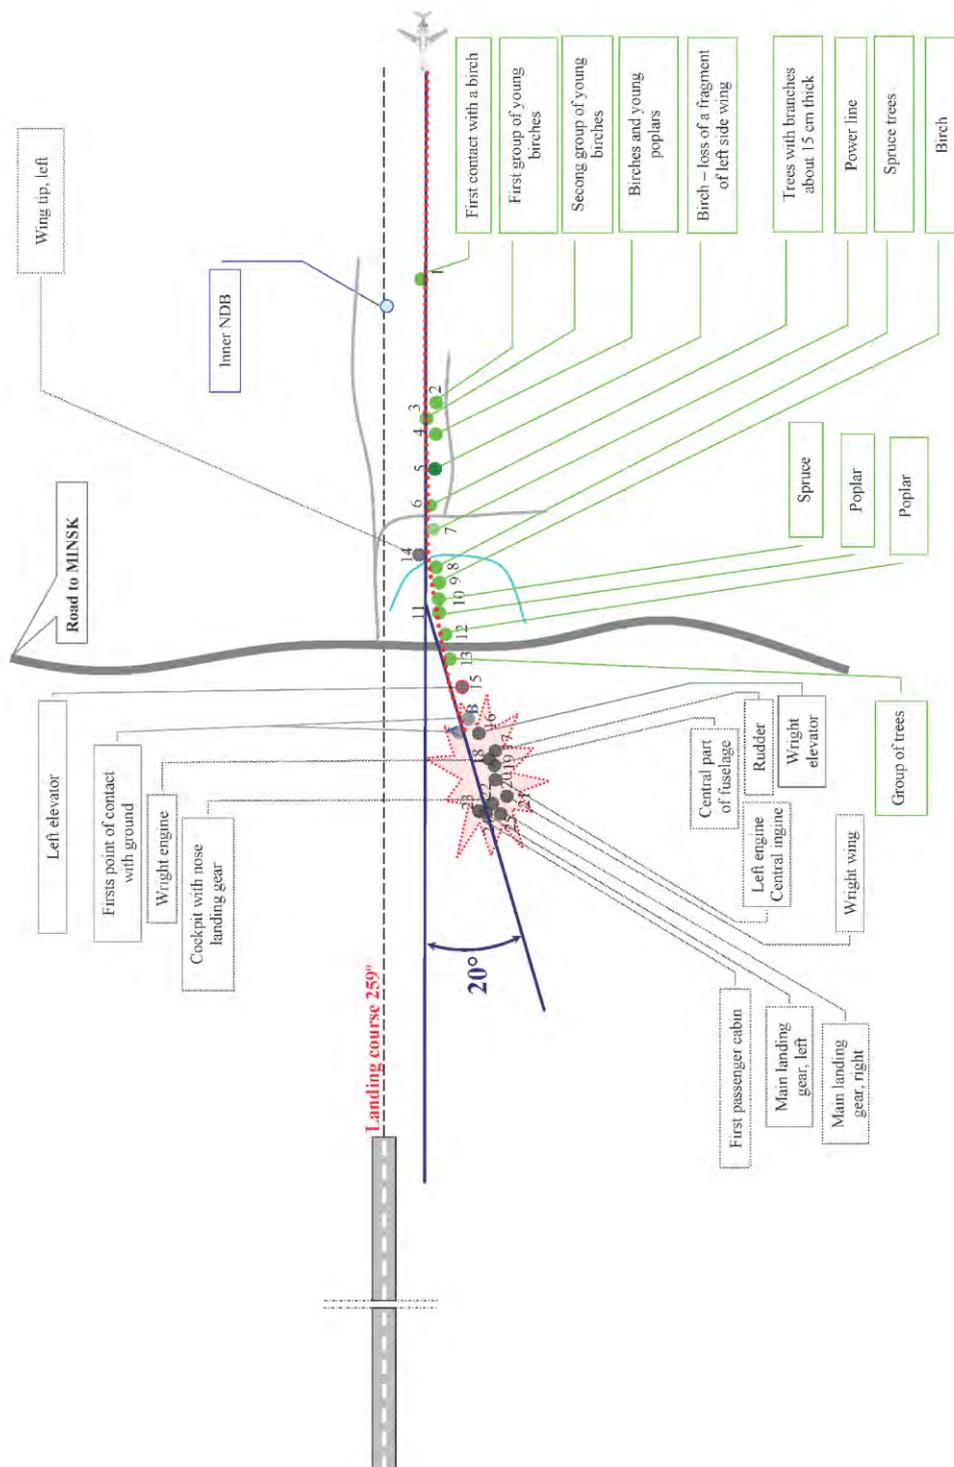
Fig. 13. Positions relative to runway threshold, of:  
 a) characteristic obstacles of terrain (points 1-13);  
 b) places of impact against ground (points A and B);  
 c) scatter of the aircraft wreckage (points 14-25)

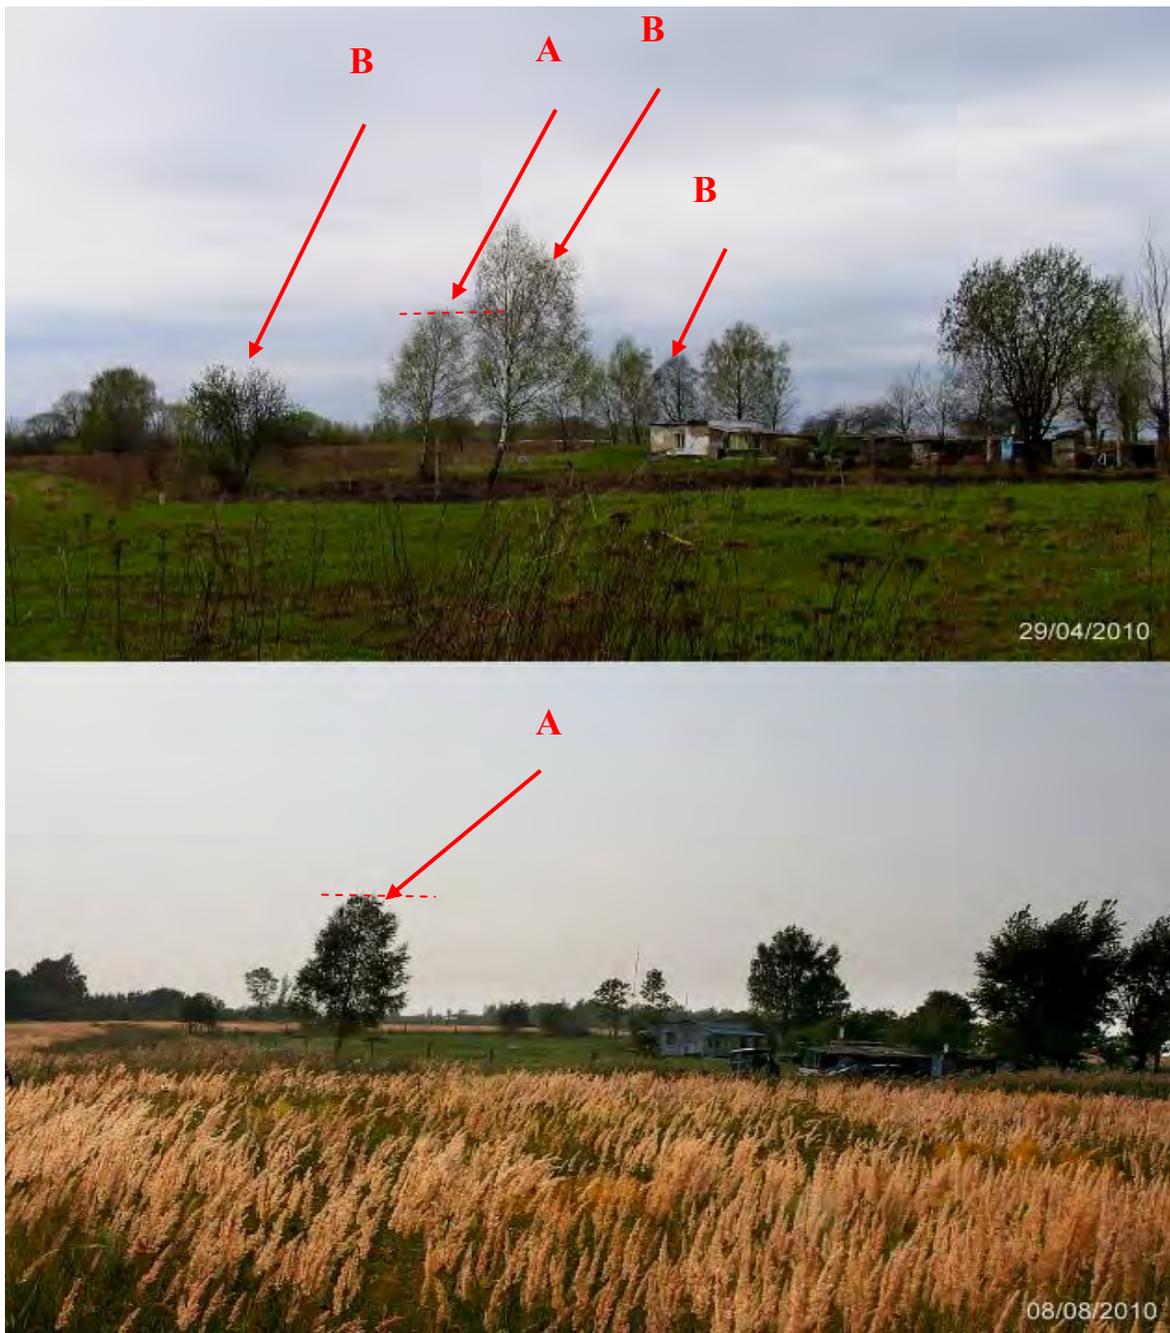
Photo 18. Surroundings of Inner NDB – Pictures taken in April and August 2010 r.  
(differences in the tree stand)  
A – the tree, trimmed by Tu-154M,  
B – trees, cut down after 10.04.2010.

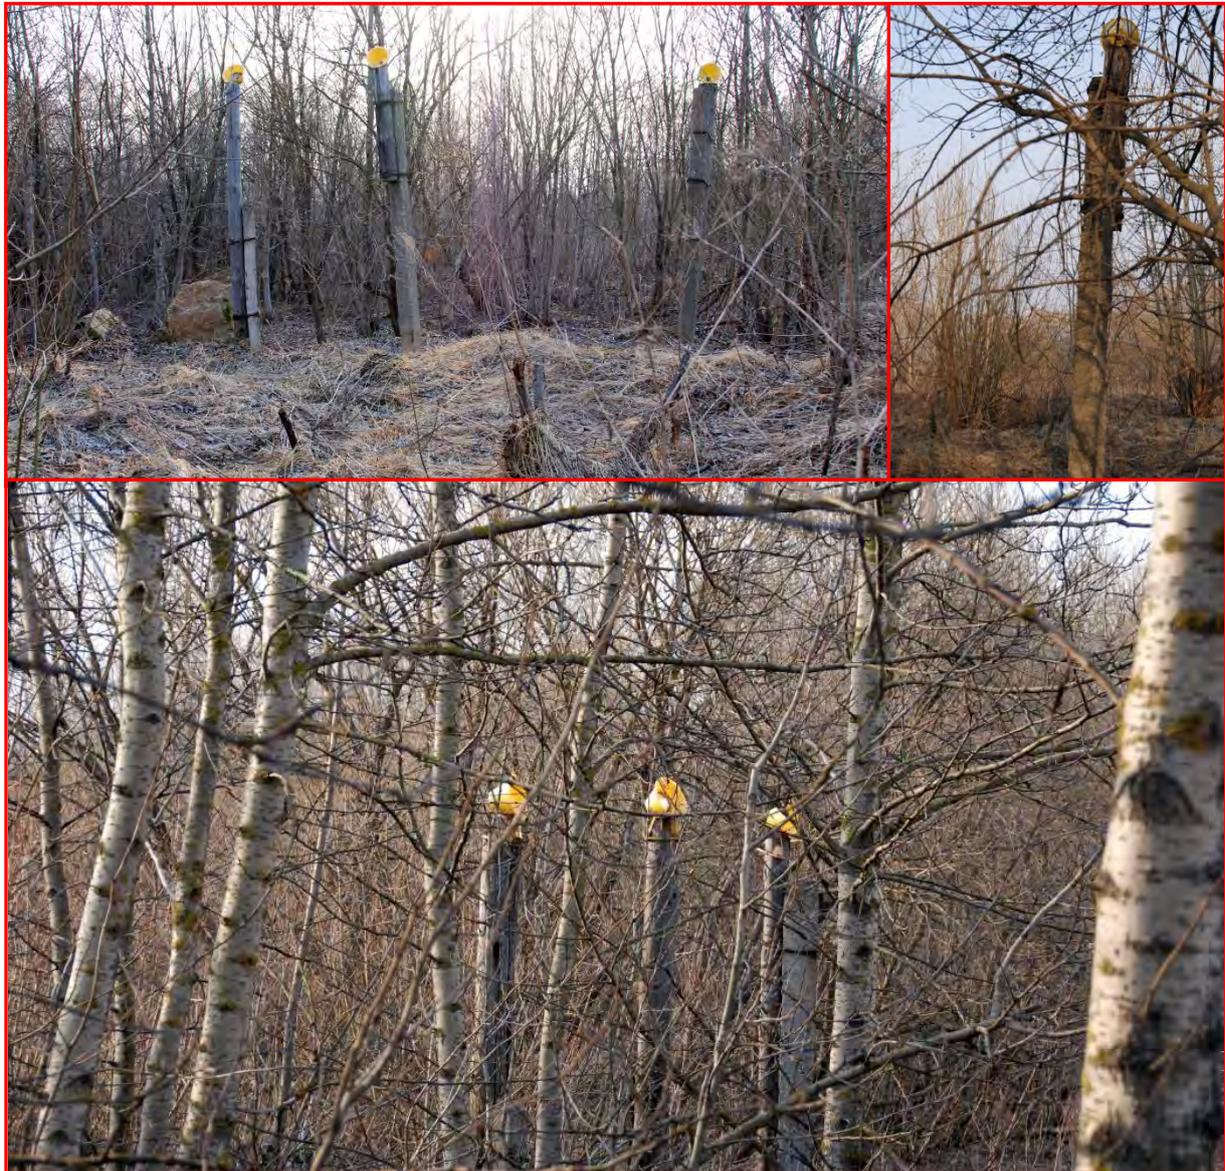
Photo 20. Navigation lamps obscured by trees and shrubs

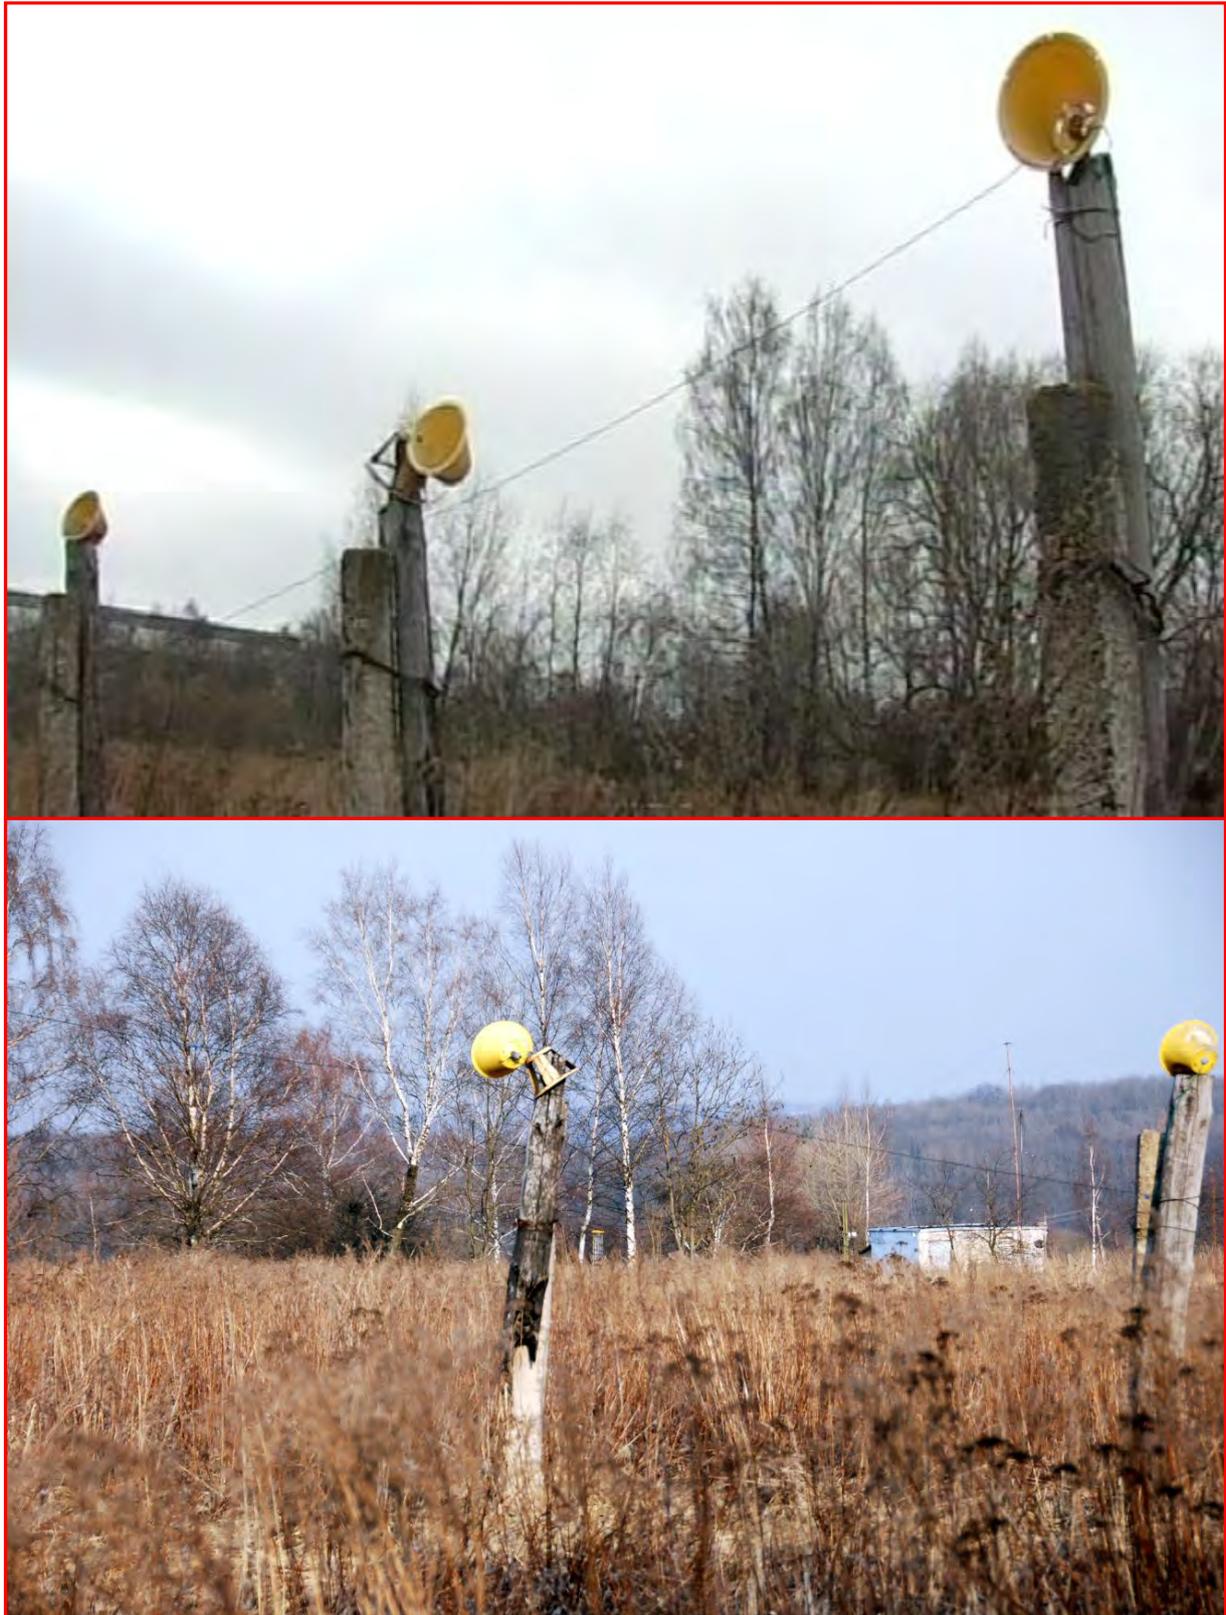
Photo 21. The technical state of approach lamps

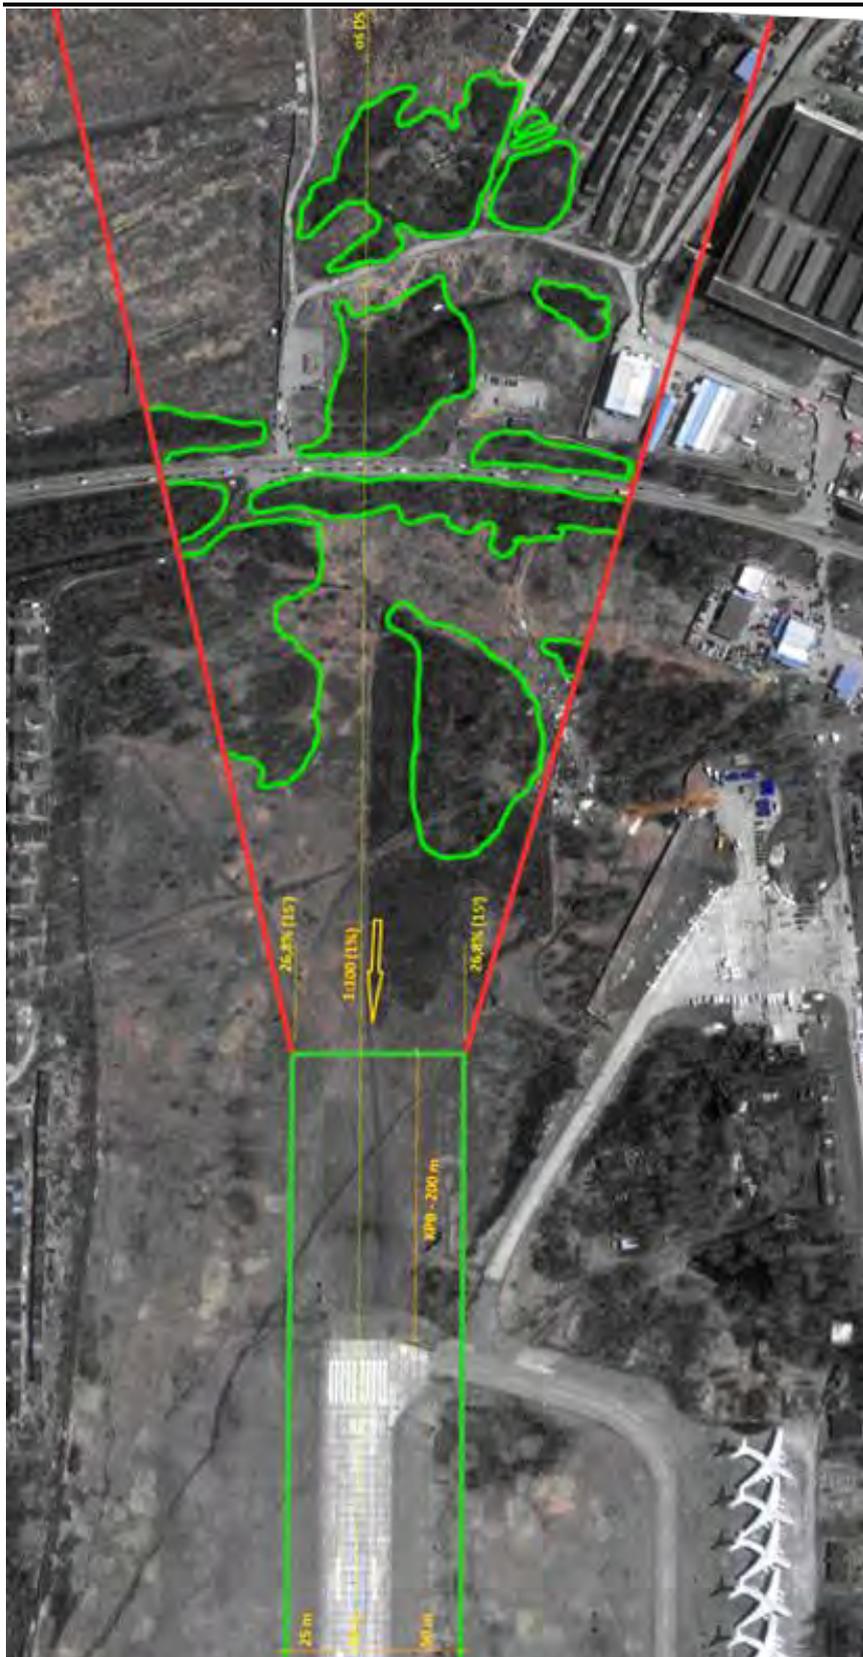
Tree stands and shrubs on the runway safety area

Fig. 18. Tree stands and shrubs in the runway safety area with a 1% slant – according to Polish regulations for military aerodromes

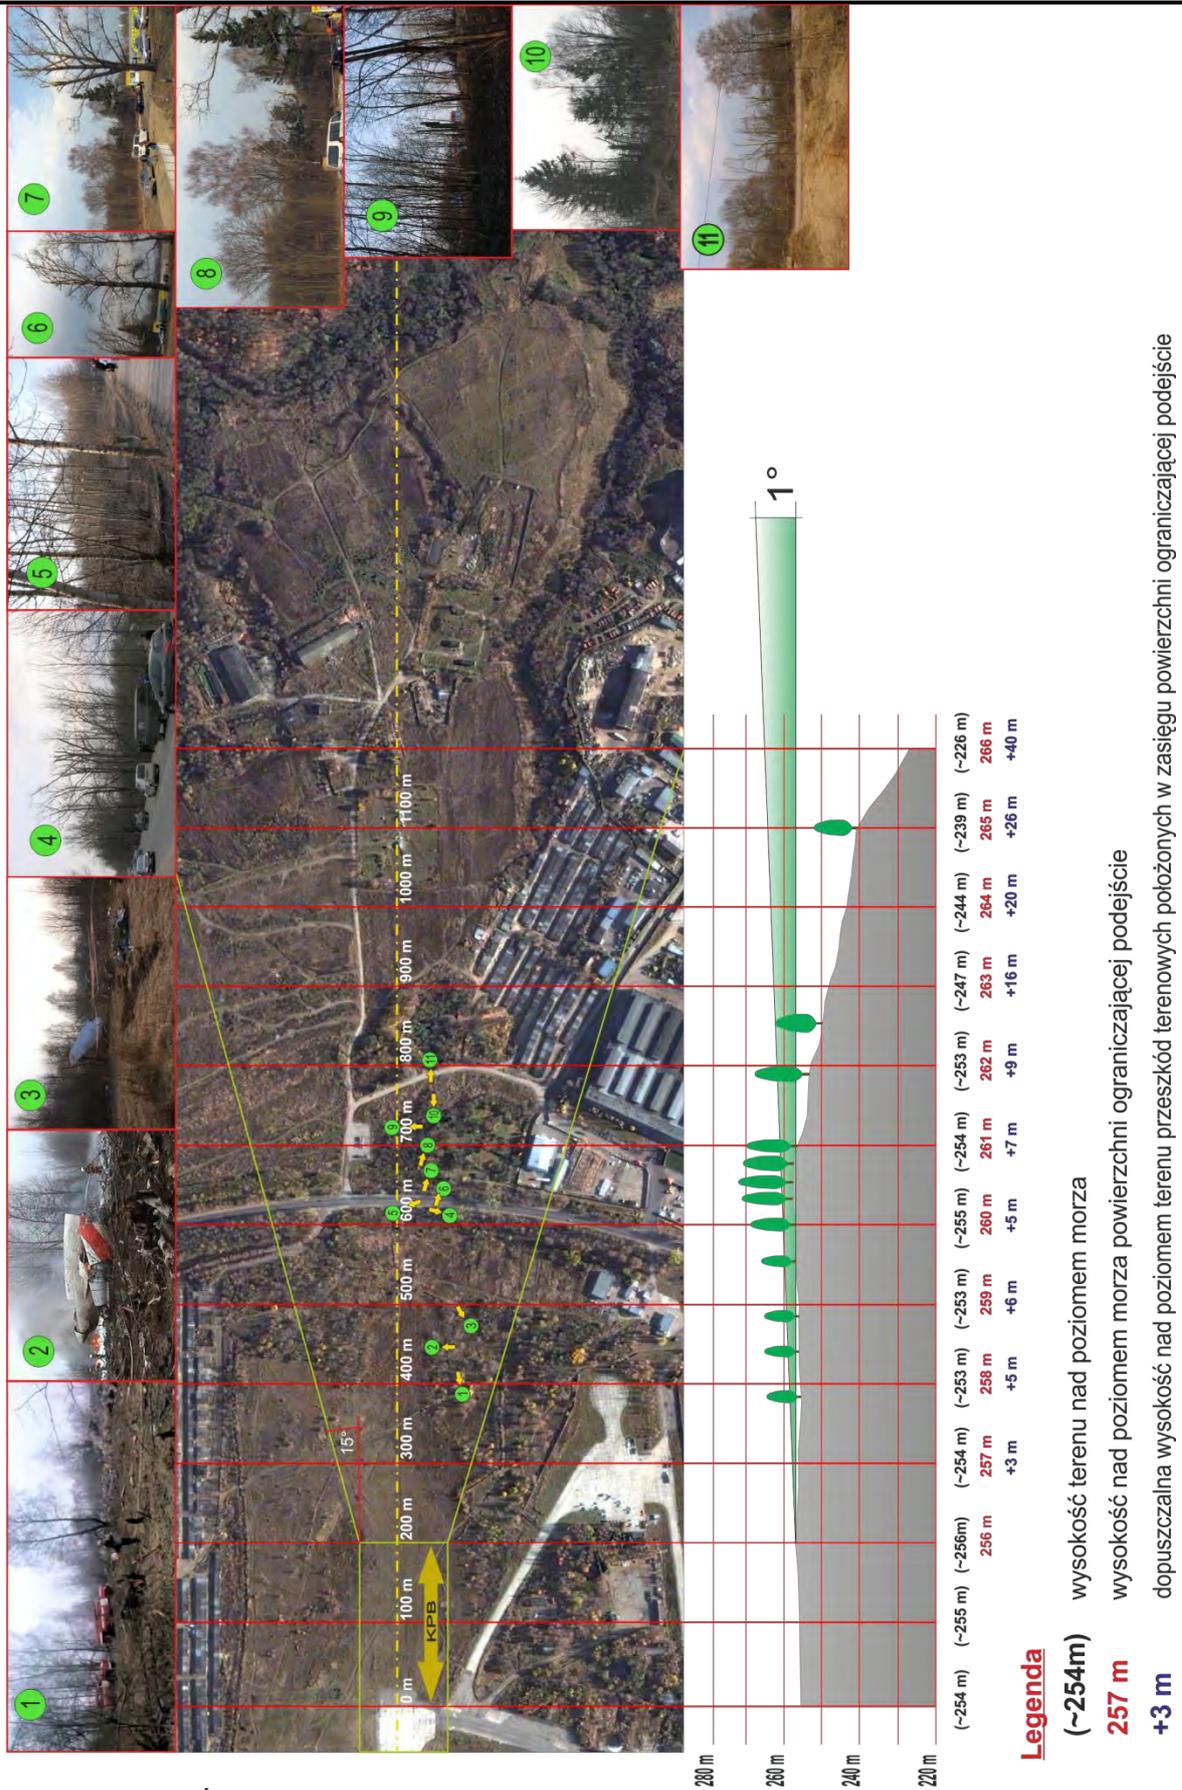
Fig. 19. SMOLEŃSK NORTH aerodrome – location of trees taller than allowable on runway safety area
