# **Final Report**

**from the examination of the aviation accident no  
192/2010/11**

**involving the Tu-154M airplane, tail number 101,  
which occurred on April 10<sup>th</sup>, 2010**

**in the area of the SMOLENSK NORTH airfield**

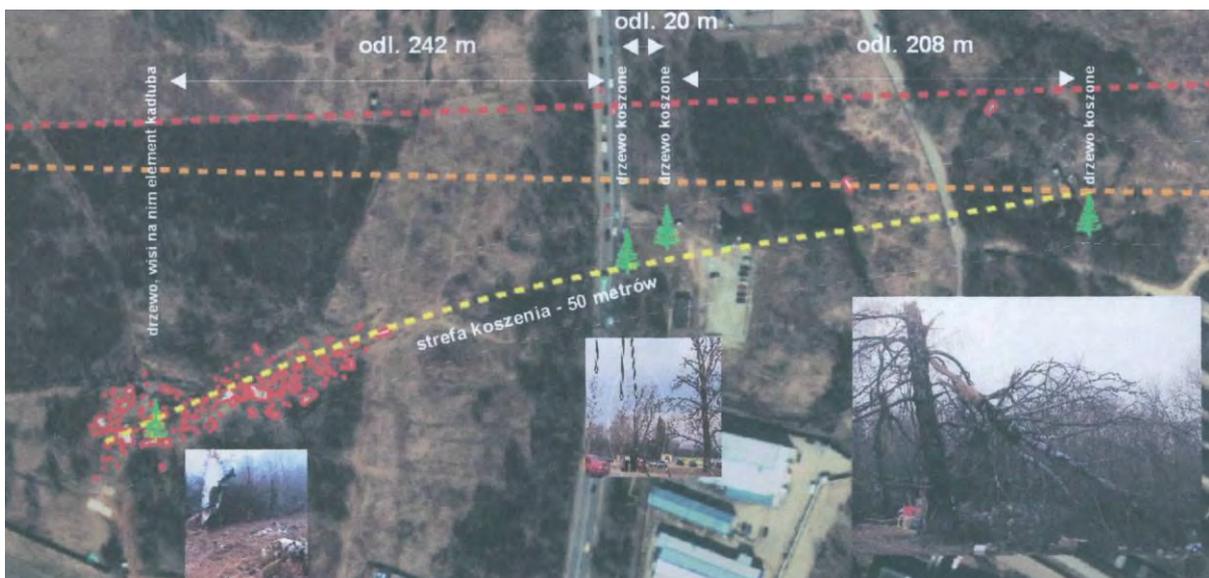
Fig. 9. Place of impact, characteristic measurements depicted.<sup>39</sup>

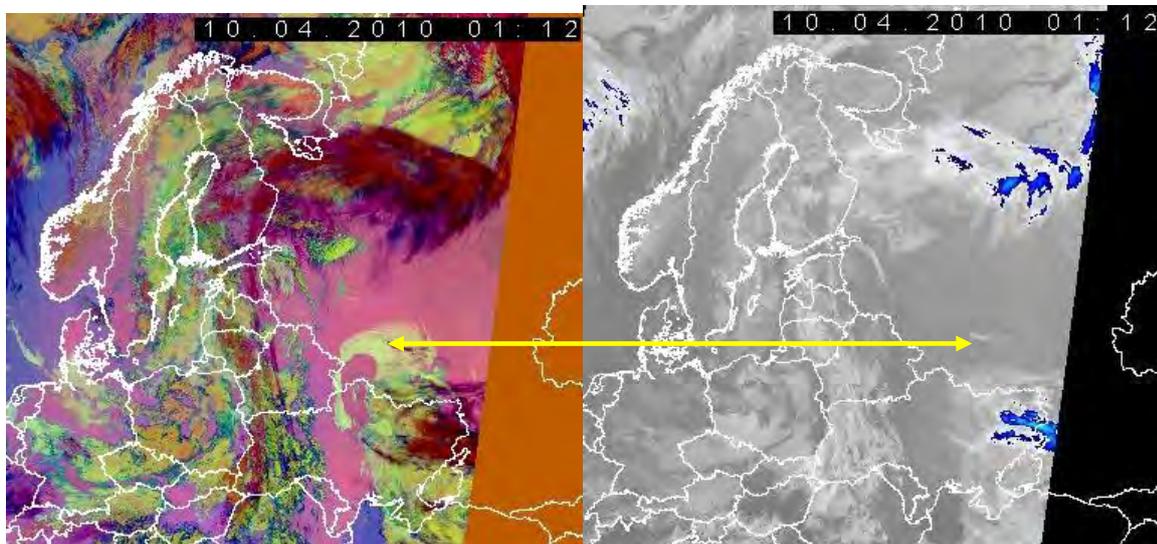
The same fragment of the photo on a thermal scale shows, solely through shades of gray, that the area of clouds/fog does not differ from the background. It is even possible to assess that the area is somewhat darker, i.e. warmer.

Fig.19. Processed NM photo NOAA-18; 01:12; 10.04.2010 Type b4BT IR photo

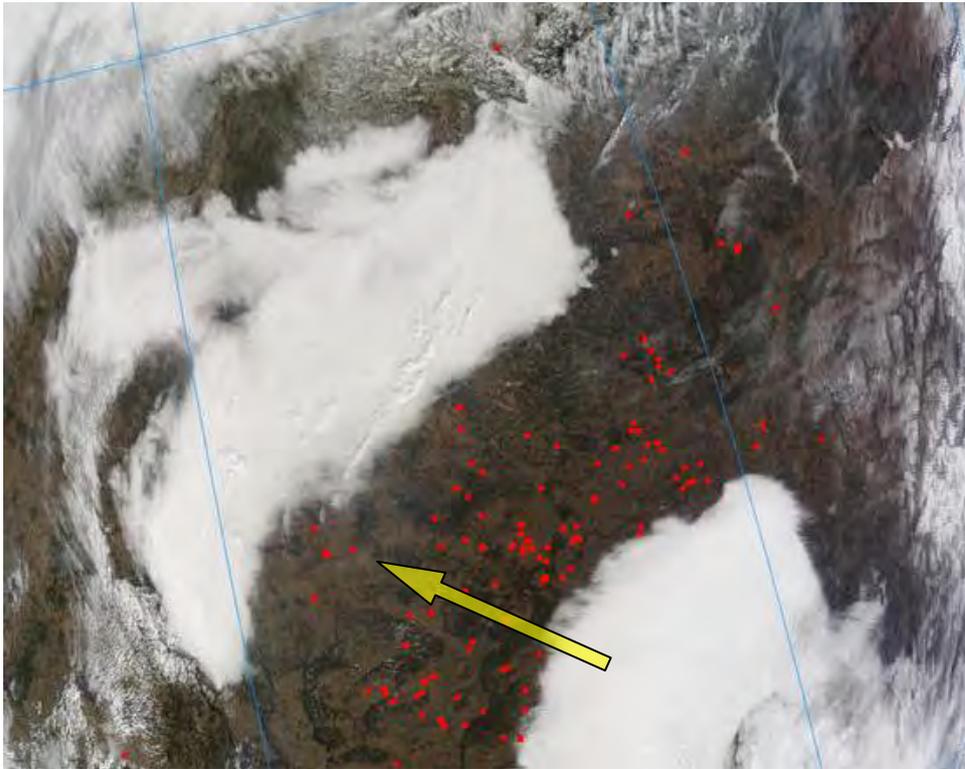
Fig.20. Yellow arrow points to Smoleńsk and shows direction and distance which the zone of stratus low layer clouds travelled with the fog from SE

In the Committee's opinion, generally accessible information from radiosondes let diagnose the cause of stratus clouds zone formation combined with fog, and establish its movement. Satellite photos show precisely its existence south of Smoleńsk even the day before as well as its slow advection during the night to NW. This zone was not clearly visible on satellite pictures in standard infrared region, yet, perfectly visible and with contour in a special array of channels destined to detect low level clouds and fog.

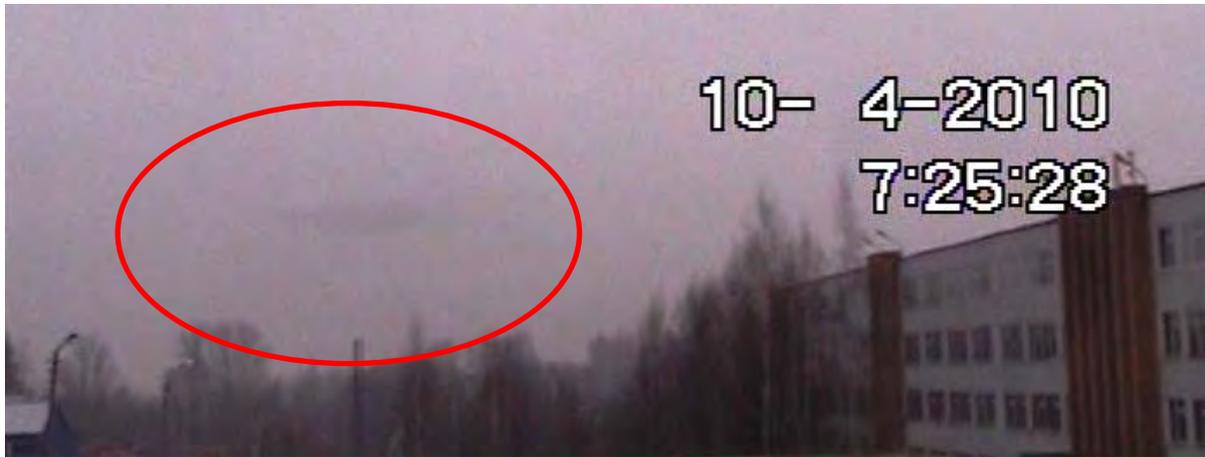
ATC twice permitted the IL-76 crew to approach twice in weather conditions below approach minima according to OCH c PCII<sup>142</sup> (in accordance to findings of the Committee, horizontal visibility at the time was between 500 m – 300 m, and cloud base below 50 m). Such ATC action was in conflict with FAP PP GosA items 20, 96, 98, 462 and 557 ref. \*9.

Fig. 24. Il-76 at first landing approach

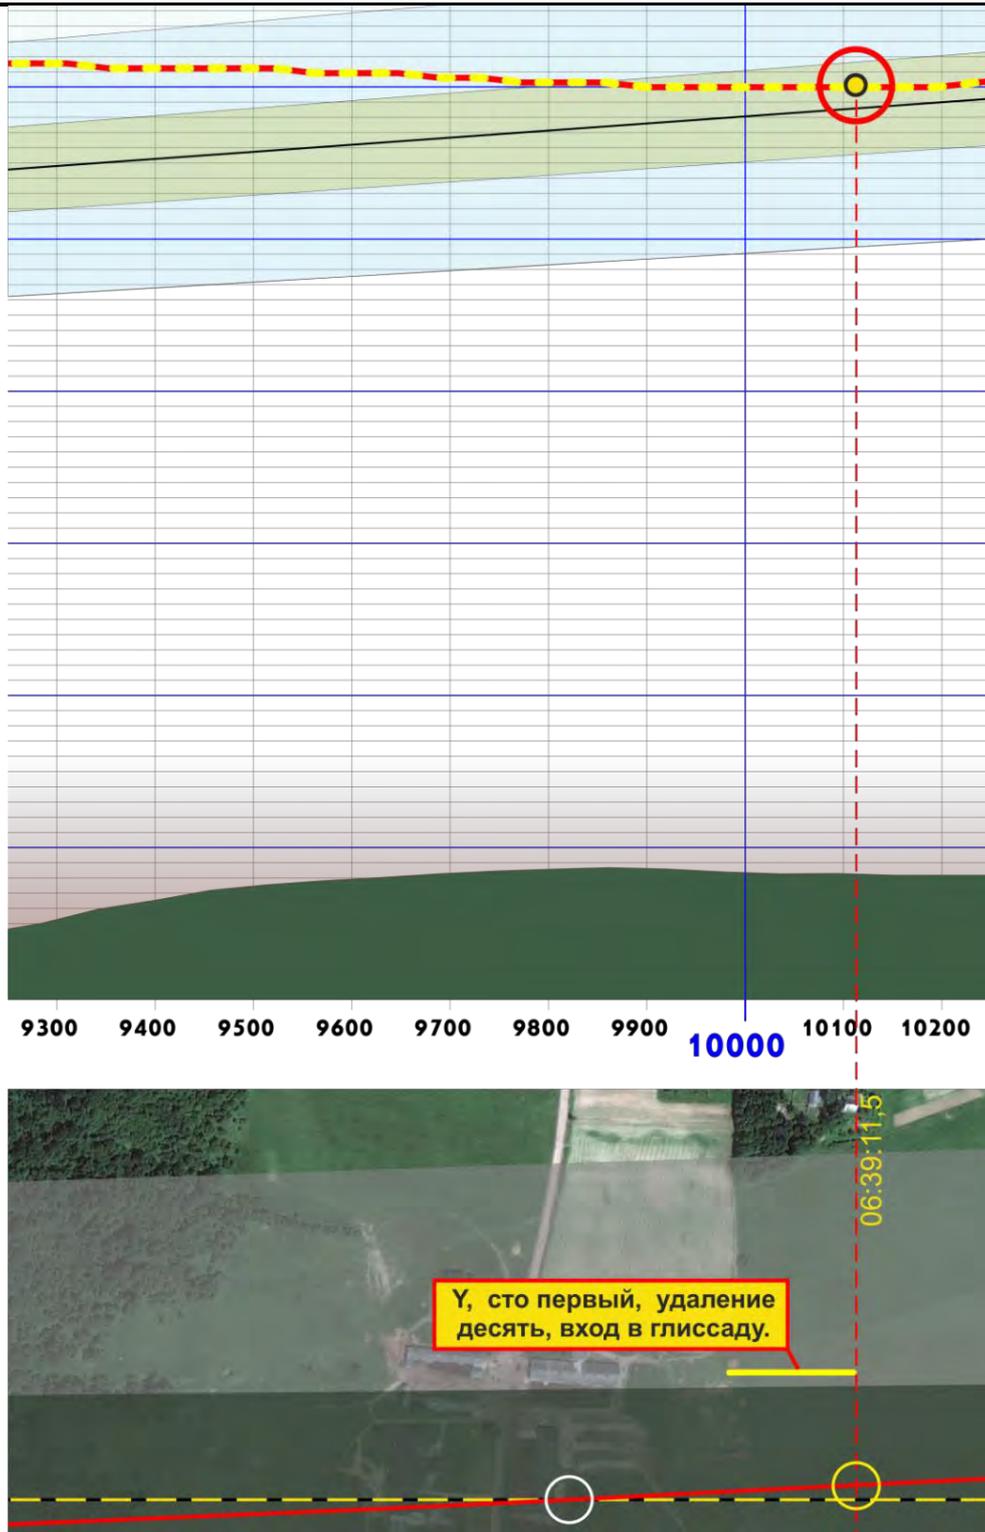
Fig. 24. Location of the aircraft at the moment of command: „Сто первый, удаление десять, вход в глиссаду”  
(One zero one, distance ten, entry into glide path)
